DECLARATION OF CHRISTOPHER G.  
BETKE IN SUPPORT OF DEFENDANT'S  
MOTION TO EXCLUDE THE  
TESTIMONY AND OPINIONS OF KEN  
RICE

## **THE BLUFFS AT EVERGREEN FIRE INVESTIGATION REPORT**

Insured: DH&G LLC  
Loss Location: 2 West Casino Rd.  
Everett, WA 98204  
Date of Loss: December 31, 2015  
File Number: 220.19486  
JH File Number: 1C0703257

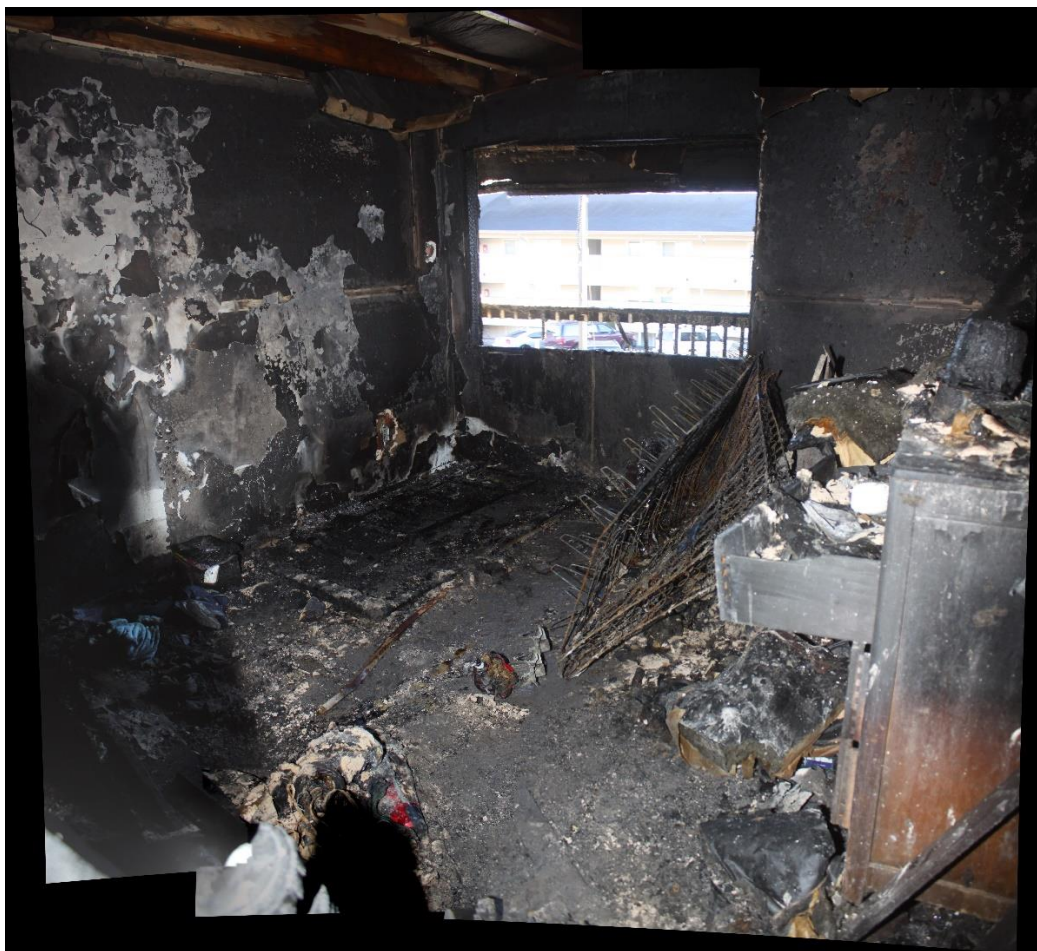
Figure 4: Composite image of SE Bedroom, taken 01/08/16, view to southeast.

1. Apartment E101 was extensively fire damaged. The fire patterns confirmed that the fire originated in the southeast bedroom and spread out into the rest of the apartment. The fire breached the south window of the southeast bedroom, spread up the exterior, and entered the attic through the soffit above the third story walkway. The fire spread east and west away from Apartment E101.

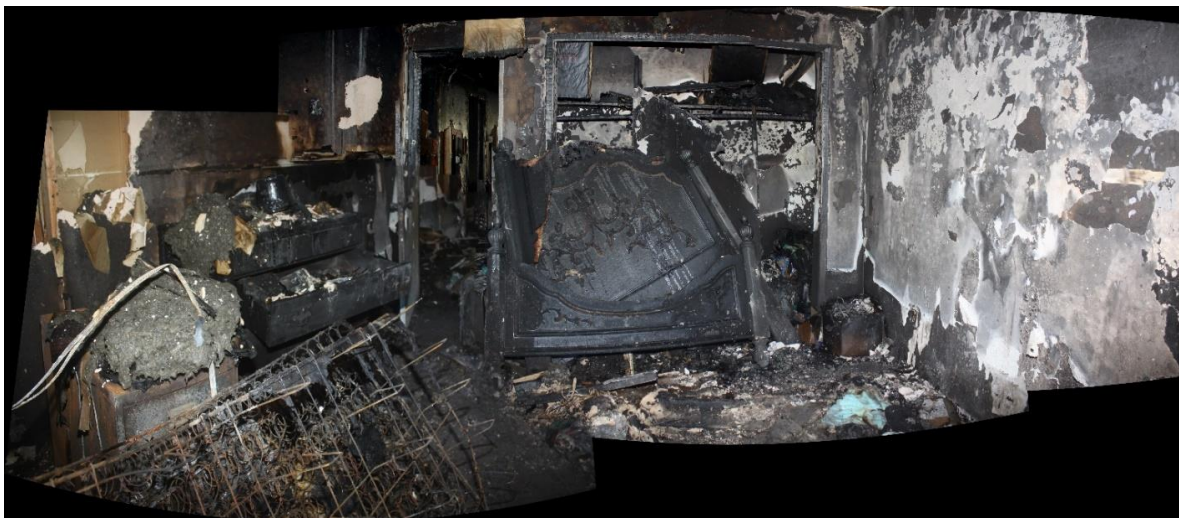
**Figure 5: Composite image of SE Bedroom, taken 01/08/16, view to north.**

2. Fire patterns in the southeast bedroom showed that the fire originated on the bed in the southeast quadrant. A fire-damaged wood base of a box spring foundation was found on the floor in this area. The box spring was a few inches away from the east and south walls. The fire damaged mattress and metal box spring frame were found leaning against furniture on the west wall. A view of the southeast bedroom is shown in Figure 4 and Figure 5.

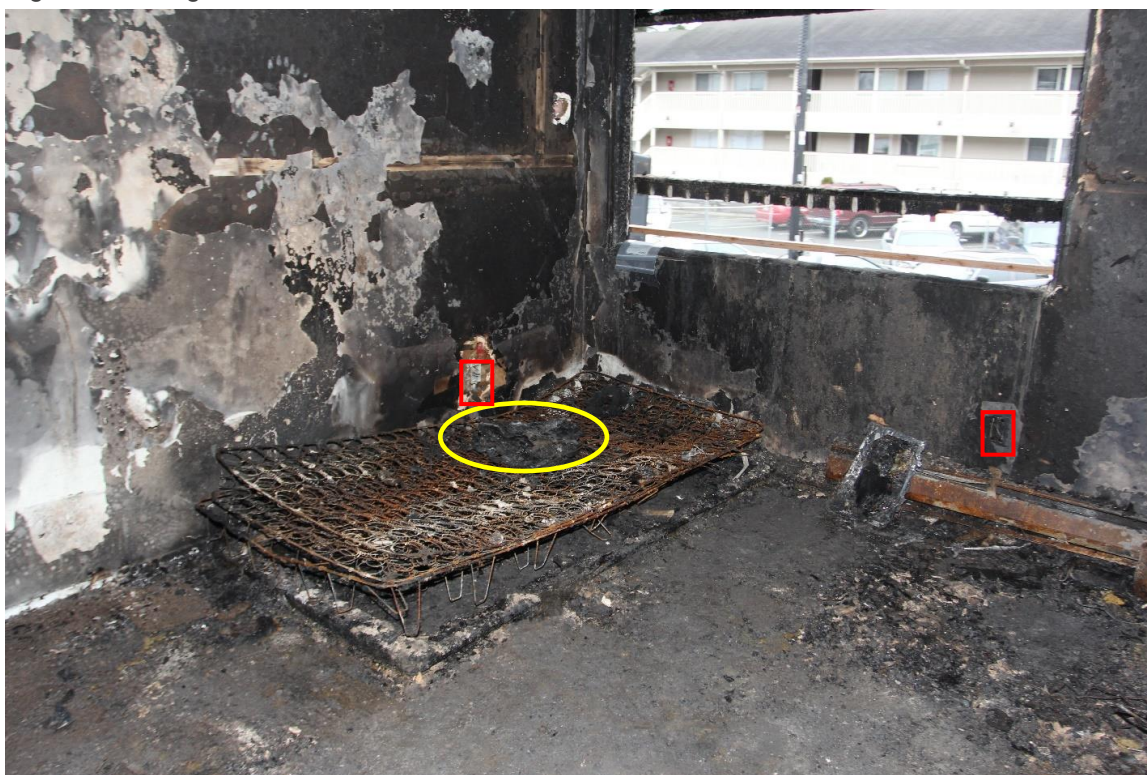
**Figure 6: IMG\_0197, SAS, 01/19/18: SE Bedroom with bed reconstructed. Protected area on mattress shown in yellow and receptacles in red.**

3. The bed in the southeast corner was reconstructed during the examinations, as shown in Figure 6. A protected area of remaining mattress material was found on the top center of the mattress.

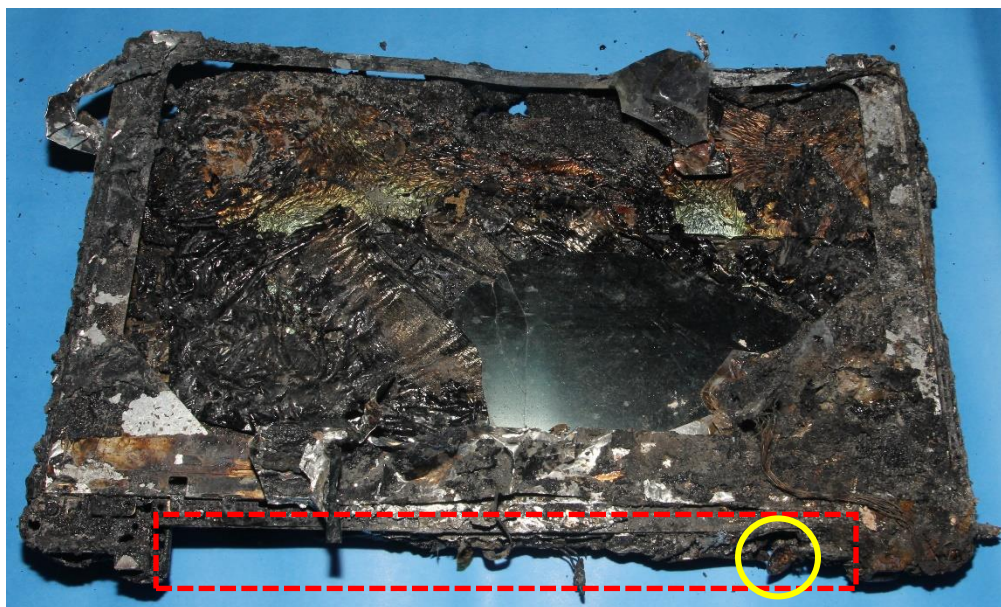
2. Item #42: Laptop recovered from the southeast bedroom
  - a. The laptop was heavily fire damaged. Much of the exterior plastic housing was burned and/or melted away. The top and under sides of the laptop are shown in Figure 10 and Figure 11.
  - b. The laptop was x-rayed, and the image showed that the internal circuit boards and components were mostly intact (Figure 13). There were no specific, localized areas of internal damage to the motherboard, hard drive or keyboard.
  - c. The battery pack area was the most significantly damaged portion of the laptop. The battery pack was still inserted into the laptop charging terminals. The top cap for one of the three Li-ion battery cells was still attached to the battery pack / laptop remains (Figure 12).

**Figure 10: IMG\_0023, SAS, 08/25/16: Top side of laptop. Location of battery pack (red) and Li-ion cell cap (yellow) indicated.**

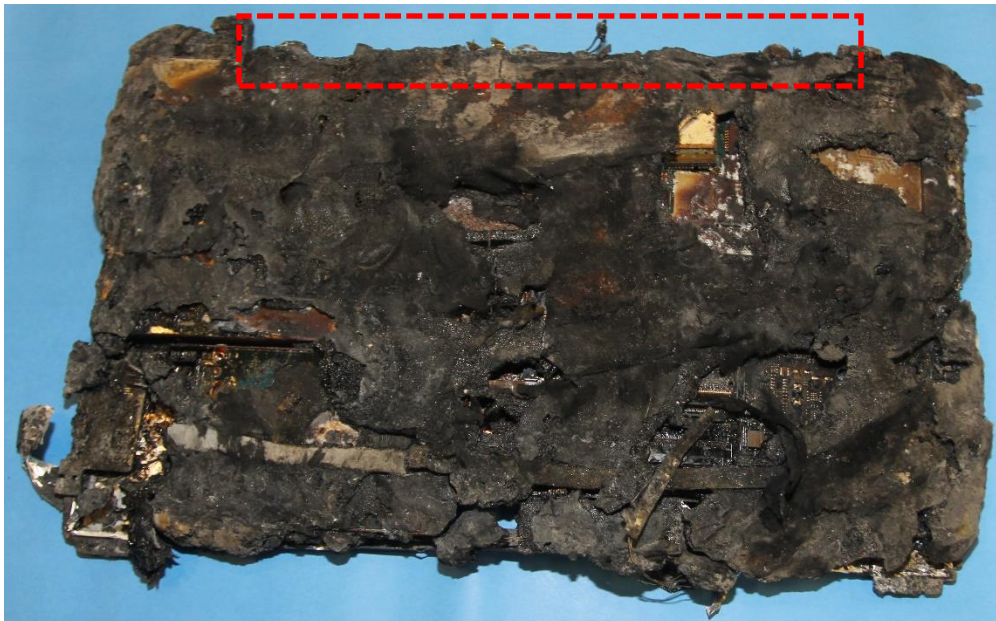
**Figure 11: IMG\_0016, SAS, 08/25/16: Underside of laptop. Location of battery pack indicated (red).**

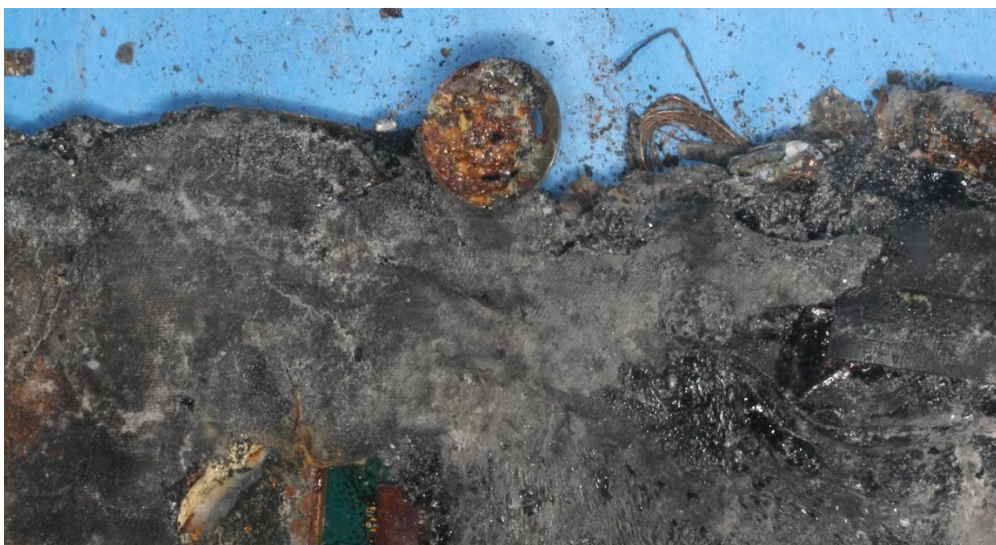
**Figure 12: IMG\_03012, SAS, 08/25/16: Li-ion battery cell top cap attached to laptop.**

- e. The cap was missing from one of the cells (Item #3, found outside) and the internal jellyroll was expelled when the cell explosively vented. The top cap matching this cell was found attached to the laptop battery pack / laptop remains. The other two cells still had the top caps attached.

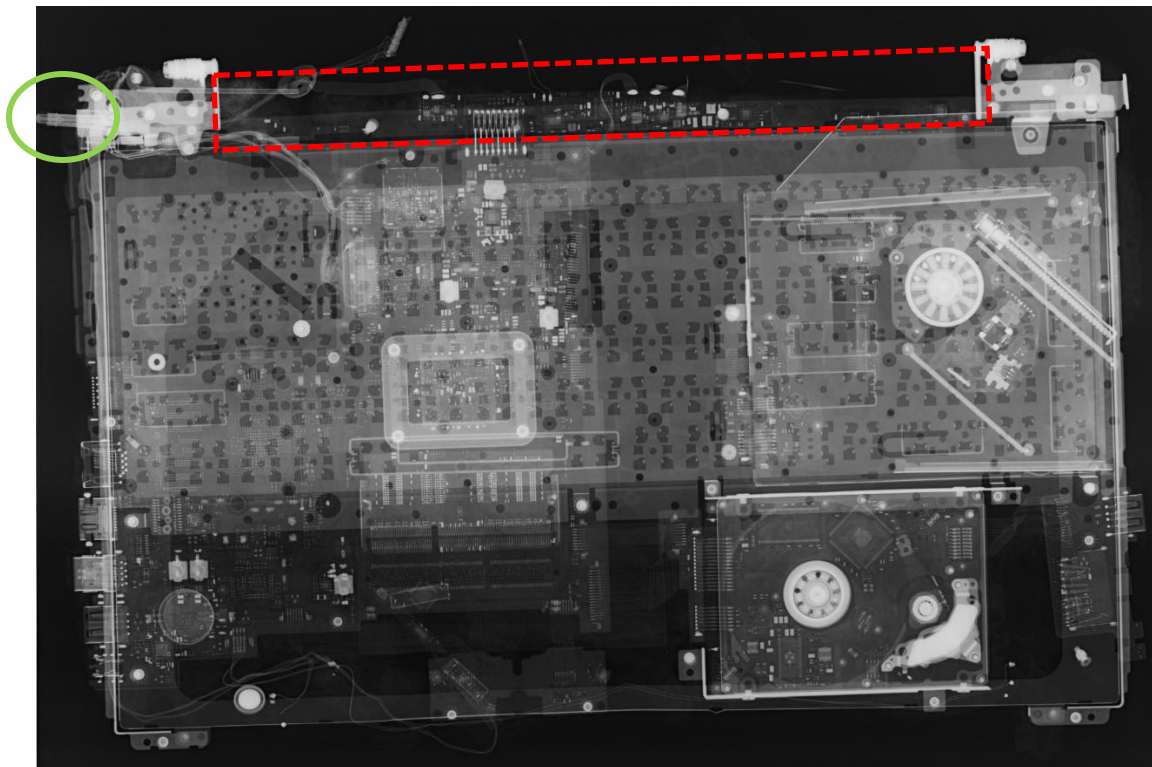
- d. The DC power plug, separated from the power cord, was found inserted into the laptop at the left rear corner (Figure 13 and Figure 14). This showed that the laptop was plugged in and energized at the time of the fire.

**Figure 13: X-ray of subject laptop. Battery pack indicated in red, and charging port with DC plug inserted in green.**

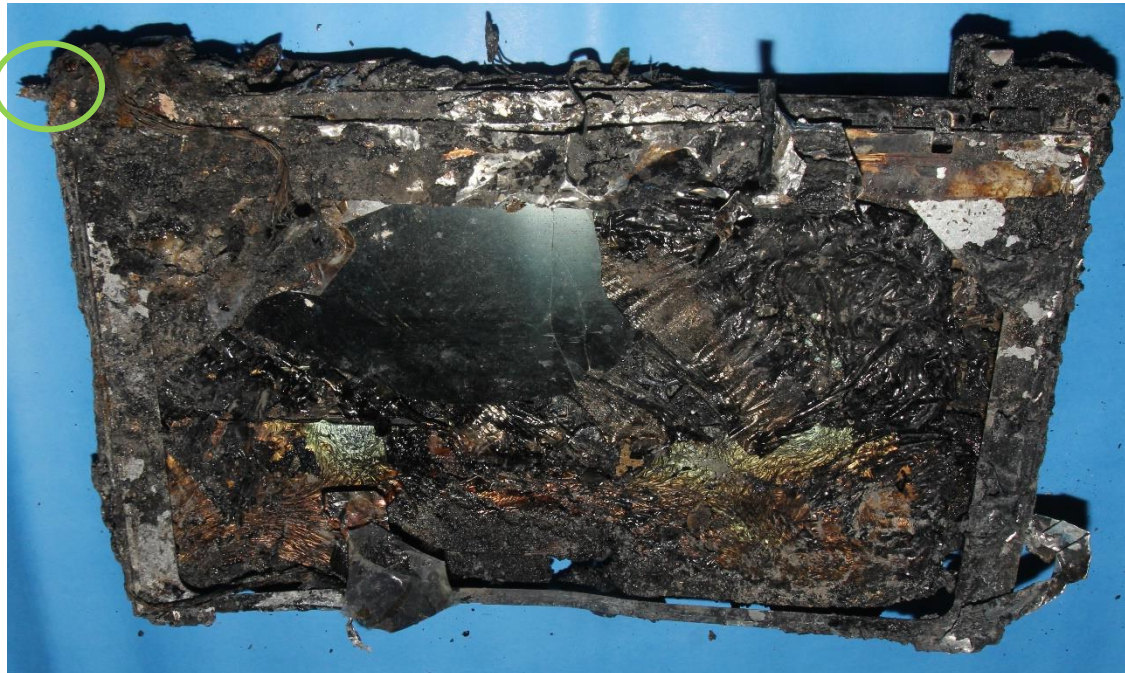
**Figure 14: IMG\_0023, SAS, 08/25/16: Laptop with DC plug inserted into the charging port.**

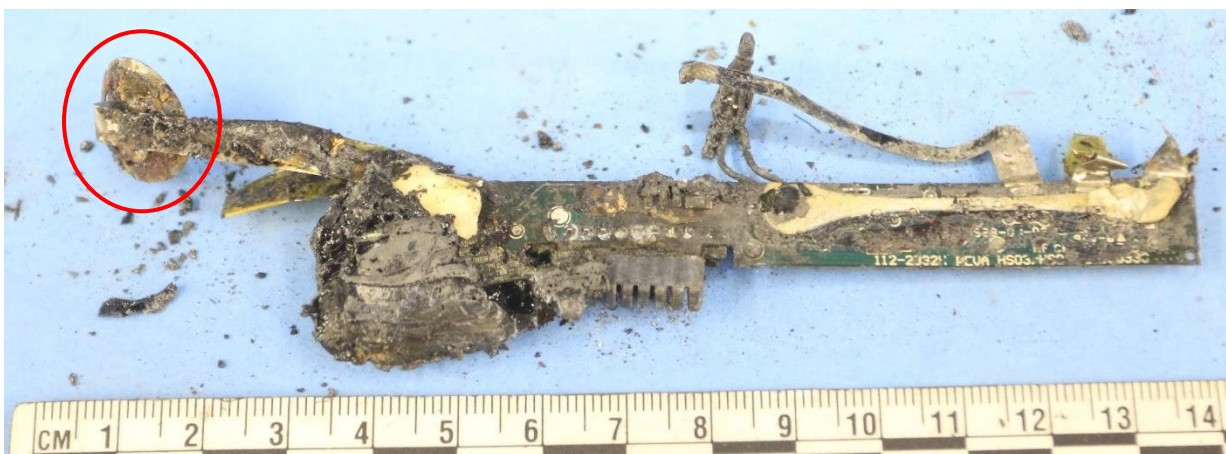
- e. The battery management unit (BMU), i.e. the control board within the battery pack, was removed from its connection to the laptop (Figure 15).
- i. The charging terminals were not melted or locally heated.

- ii. A secondary fuse protection device on the BMU was found melted open. This fuse cuts off charging current to the battery pack. This fuse could melt due to external heat or from an overcharge / voltage differential event.

- iv. The current sense resistor measures charging and/or discharging current. This resistor was electrically closed (i.e. intact, not open).
- v. Other components on the BMU were damaged in the fire and could not be measured.

**Figure 15: IMG\_0177, DTS, 03/20/17: Subject BMU with top cap of cell still attached (red).**

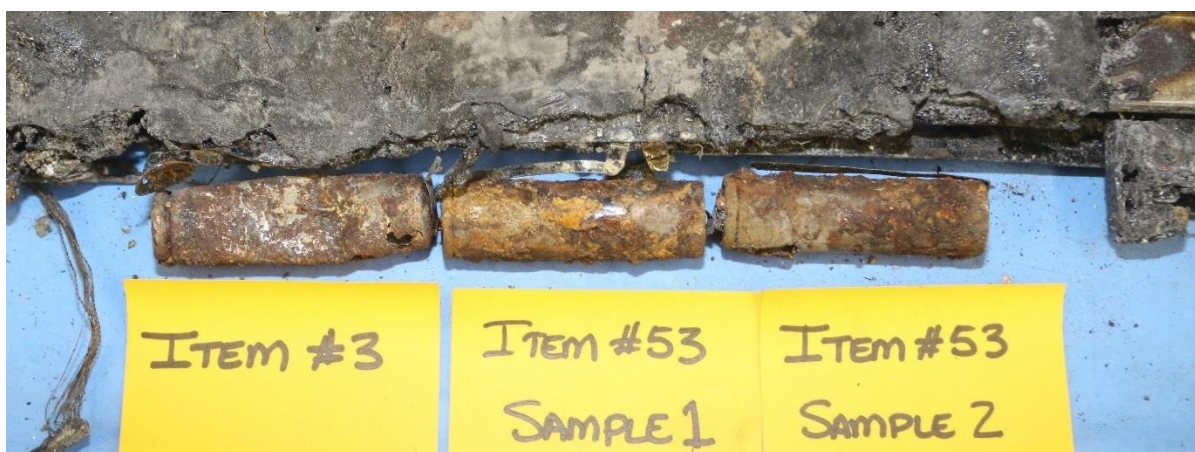
**Figure 16: IMG\_0143, DTS, 03/20/17: Subject Li-ion cells placed back in their original configuration.**

- c. HP identified the manufacturer of the cells as Samsung.
  - d. All three battery cells were fire-damaged and corroded. The steel cans were corroded and had irregular shaped holes that penetrated the can wall. They had all vented their electrolyte.

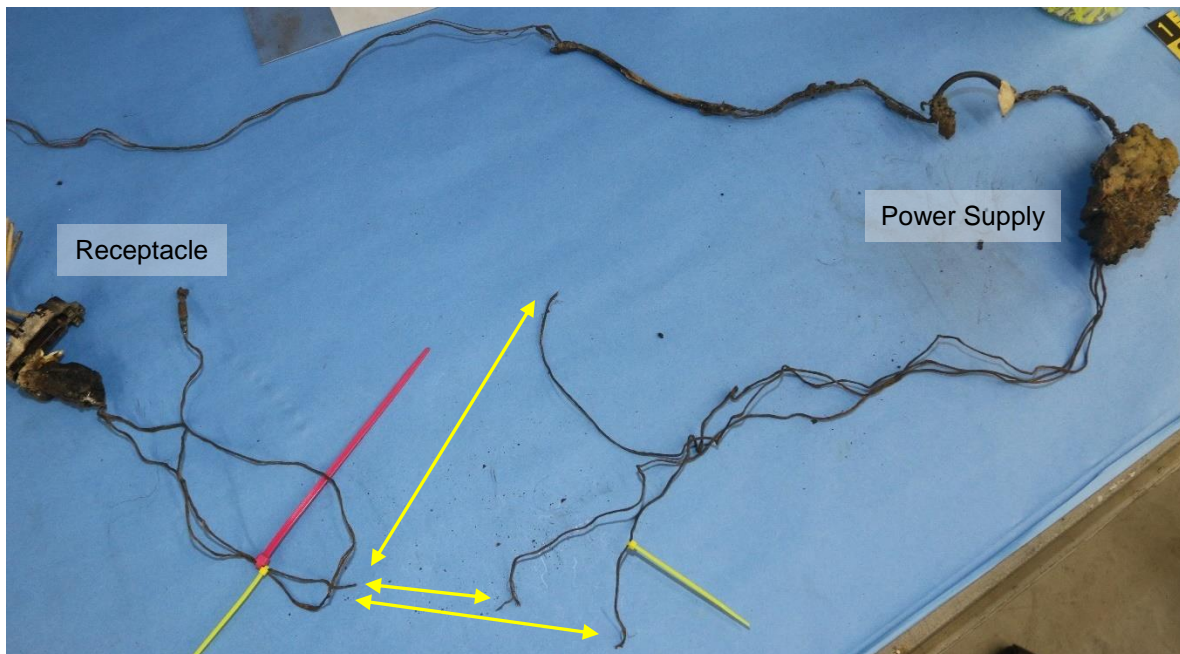
- ii. The line cord was fire damaged and much of the insulation was burned away. The line cord was severed approximately 11.5-inches from the receptacle. The severed ends showed evidence of melting and beading indicative of electrical arcing.

**Figure 17: IMG\_0035, SAS, 03/20/16: Laptop power supply, receptacle, and arc-severed line cord.**

- f. The arcing on the laptop power supply AC line cord was the furthest downstream arcing found in the room of fire origin, based on the routing of the circuit. This arc mapping evidence correlates with the witness statements and burn patterns that showed the fire originated on the bed in the southeast quadrant.
